# Dry Hire Done Right: Every Site. Every Time.

## Case Study: Coogee Baths Project!

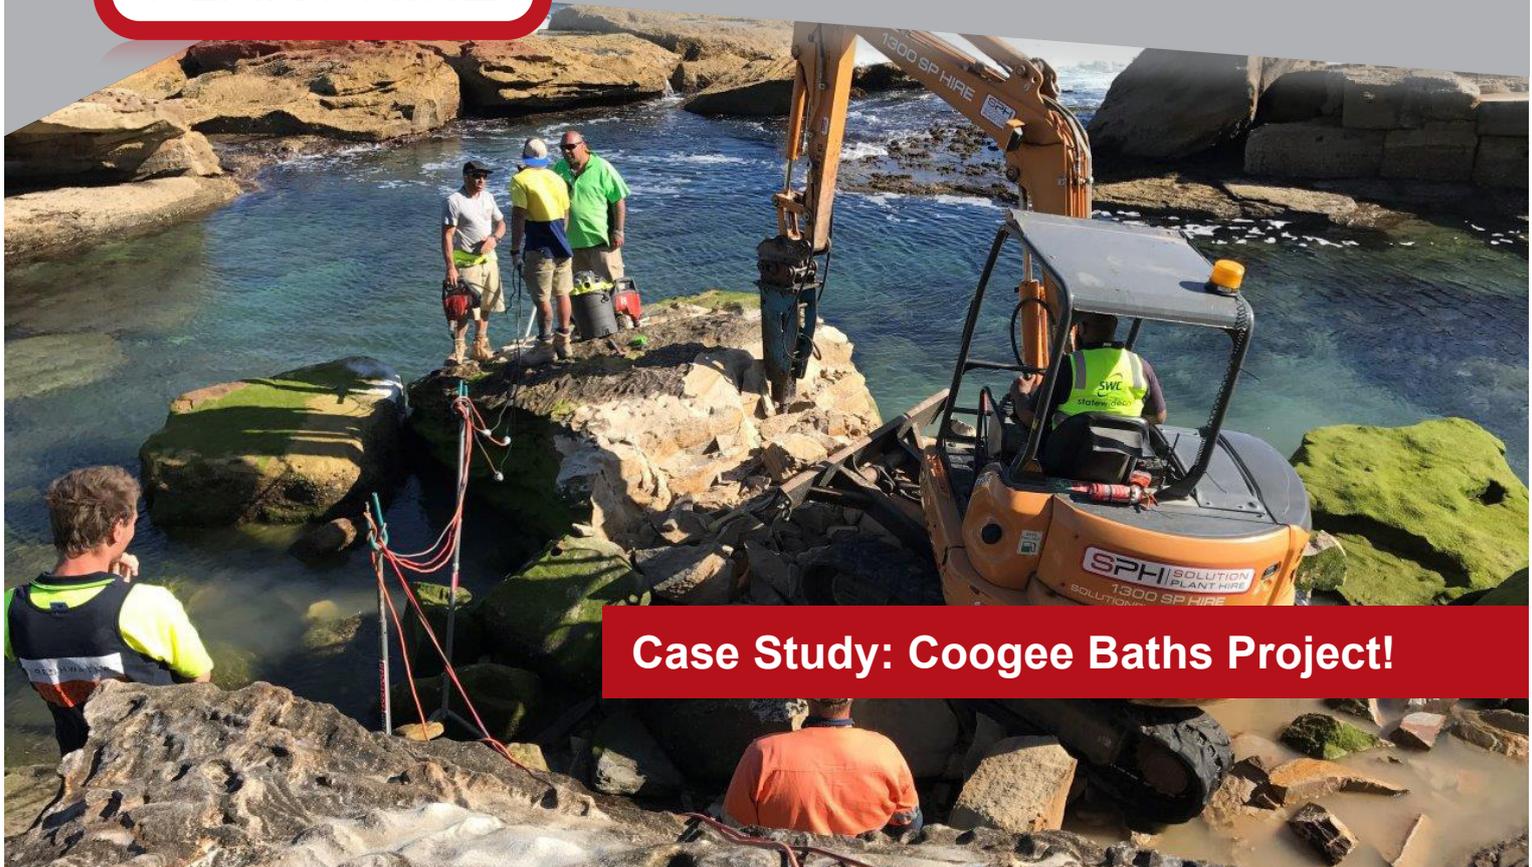
Sydney saw its fair share of wild weather throughout 2016, the storm which hit Coogee in June was no exception, during which a 30-tonne boulder made its way into the popular Coogee Baths. Over the months afterward Randwick Council explored a number of ways to remove the giant boulder.

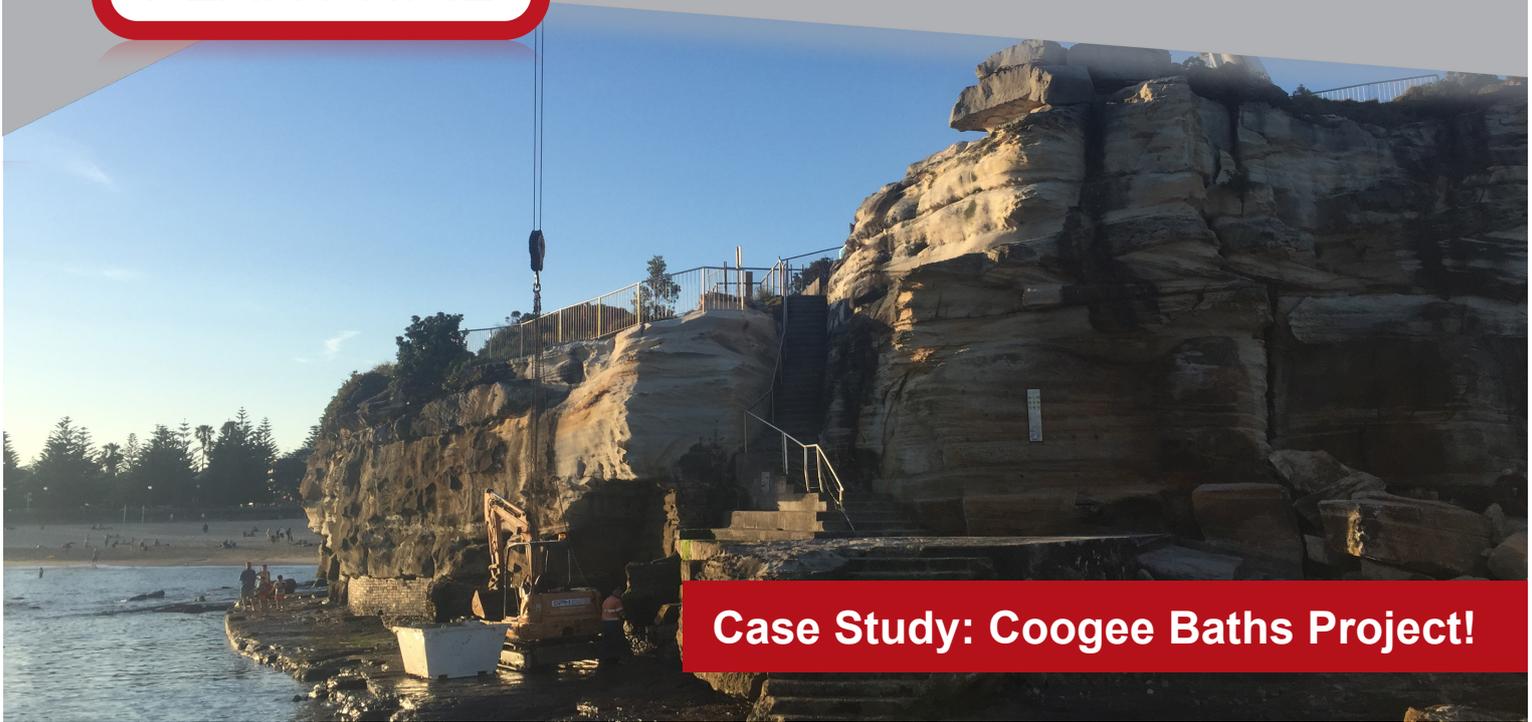
5.5T Excavator was the biggest Excavator which could be used. A 180-tonne crane was fixed at the top of Dunningham Reserve at Coogee to winch down our two 5.5T excavators and hammers each day to break the rock and then remove it from the Baths. Then as the tide came in the crane removed them back up to Dunningham Reserve.
